## Use of natural resins in repairing damaged timber beams – An experimental investigation

To cite this article: A I Osofero *et al* 2019 *IOP Conf. Ser.: Mater. Sci. Eng.* **640** 012040

# Use of natural resins in repairing damaged timber beams – An experimental investigation

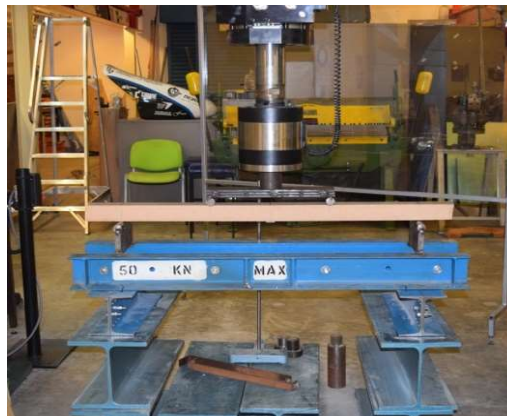
The test set up included an actuator and a testing steel frame with data acquisition system as shown in figure 1. To achieve four-point bending, a spreader beam which allowed the force from the actuator to be applied at two locations along the length of the beam was used. The tests were displacement controlled at a rate of 4 mm/min. Bending load was applied until failure for all beam specimens tested.

**Figure 1.** Test set-up (span between supports = 1004 mm and load span = 400 mm).

Bending tests were carried out over a span of 1000 mm. Supports were made of steel cylinders with a diameter of 25 mm and the distance between the two point loads was kept at 400 mm. The actuator, through which vertical load was applied on the spreader beam, which in turn apply two point loads on the beam specimens, is of the model 2518-113/UK068 and characterized by a 250 kN capacity load cell. The layout of the timber beam, supports and load application points are shown in figure 1.

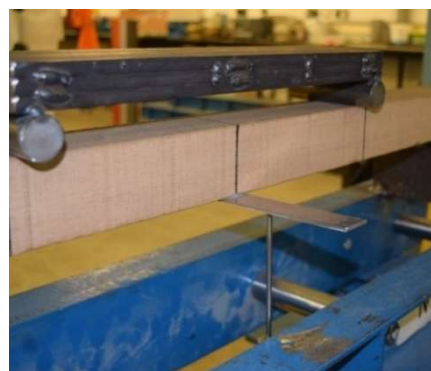
Linear Variable Displacement Transducer (LVDT) was used to measure maximum beam deflection (at mid-span) for every load increase as shown in figure 2. To attach the LVDT, a steel plate was glued to the tension side of the beam at the mid-span and the transducer sensor was set up such that it just touches the underside of the steel plate. The Instron machine and the linear transducer were then synchronized to ensure corresponding output at a frequency of 1 Hz were obtained.

**Figure 2.** Measurement of vertical deflection at mid-span using LVDT.

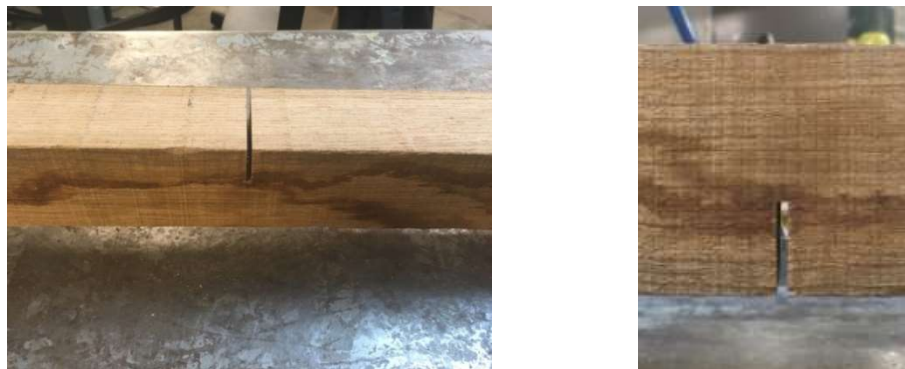
**Figure 3.** Damaged beam specimens (cut dimensions: 20 x 67 mm).

A total number of 15 small timber beams were tested in four-point bending. The timber beams were from European Oak (D30) with nominal dimensions of 67 x 67 x 1100 mm and approximate density of 670 kg/m<sup>3</sup>. Applied load and mid span displacement at failure were measured and recorded. Prior to testing, the beams were numbered, measured, weighed. The moisture content of each beam was also measured (table 1). Subsequently, controlled damage, represented by a machined cut of 2.85 mm thickness and 20 mm height were introduced in 12 of the beam specimens (figure 3), while the remaining three were used as control specimens.

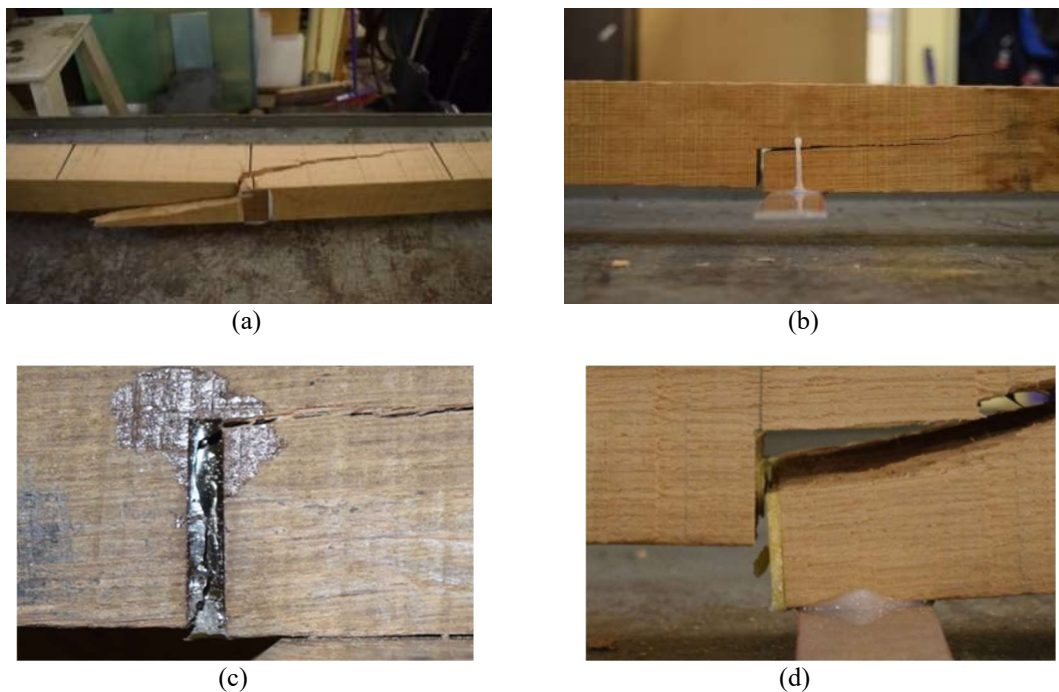
**Figure 7.** Specimens' failure modes: (a) CT series (control undamaged beams); (b) DUT series (damaged and unrepaired beams); (c) BRT series (damaged and bone glue repaired); (d) RRT series (damaged and rosin repaired).

The failure mode recorded for undamaged (control) beams was characterized by the opening of a lesion at the beam mid-span, which then spread along the beam in the direction of the grain (figure 7a). The load-displacement curves for these beams are presented in figure 6. In addition, the maximum load ( $P_{max}$ ) and the corresponding maximum ( $d_{max}$ ) at mid-span were obtained (table 2). Stiffnesses obtained at the

The most common failure mode was the opening of a crack starting from the top corner of the cut, which was then propagated in the direction of the grain (figure 7b). An average linearity index of 1.3 was recorded showing significant reduction in the load – deflection slope as the load increases. This is probably due to the plasticization of the wood fibers in the compressed area of the beams.

Similar to the damaged un-repaired beams (DUT series), the beams repaired with natural resins, i.e. bone glue (BRT series) and rosin (RRT series), failed by the tensile rupture of the wood starting from the corner of the cut with consequent breaking of the resin present inside the cut (figures 7c and 7d). Same indices previously defined were also obtained and presented in table 2 for the BRT and RRT beams. It can be observed in table 2 that the use of bone glue results in higher load carrying capacity for the repaired beams when compared with rosin repaired beams. Results were unsatisfactory both in terms of bending capacity and stiffness: the application of the natural resins was unable to restore the continuity in the area of the cut. Failure occurred in the timber material on tension side inside the cut. At failure, natural resins only deformed (no failure) or detached from the timber. The main problem was the extremely low Young's modulus of the natural resins used.
